REPAIRING Cantilevered Balconies

by Angus Smith

The right flashing details, reinforced framing, and durable waterproof decking give new life to old balconies

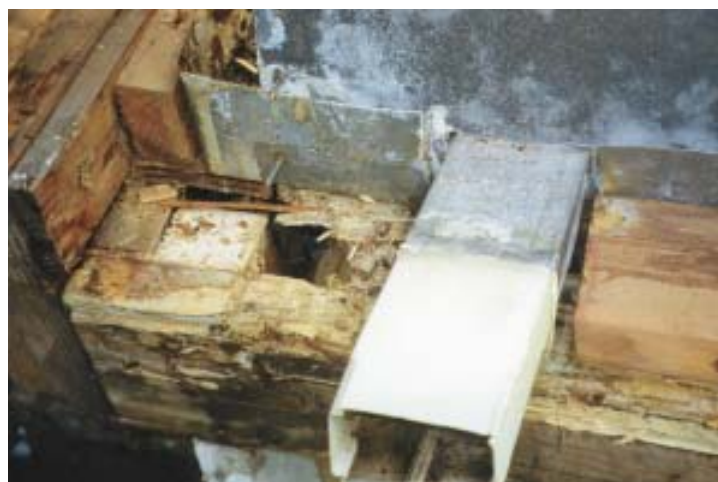
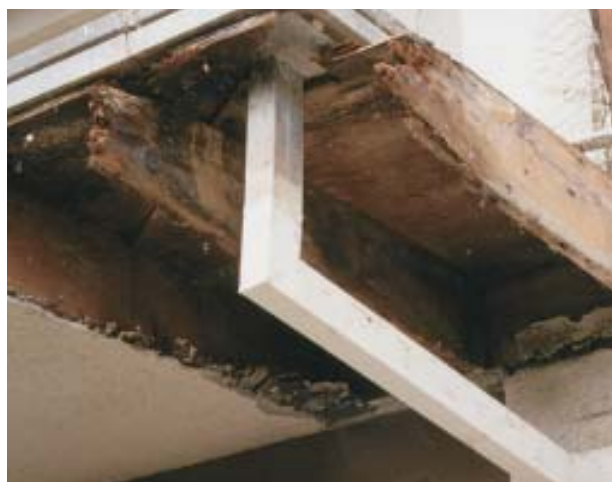
which makes for easy construction and provides privacy for the residents. It also prevents runoff from a balcony from dripping directly onto one below, but at a cost: The rainwater that falls onto each balcony must be collected and directed outside. This is usually handled by a floor drain or an open, floor-level scupper draining to a gutter. Either drainage method can lead to rot unless the spout that passes through the framing is properly installed and sealed (Figure 2).

Figure 2. Improperly flashed scuppers (left) and floor drains (right) often allow water into the framing, leading to hidden rot.

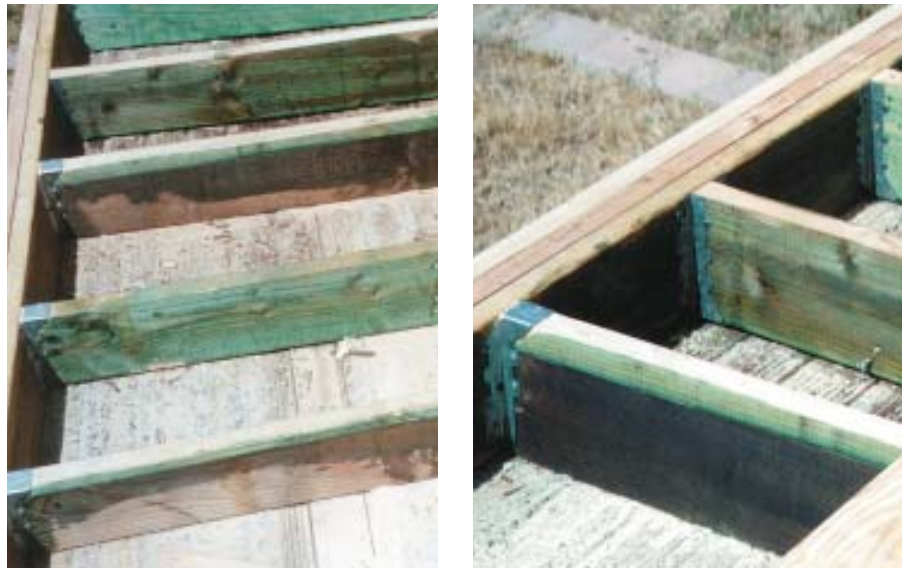
Shifting the load. Joists that are too far gone to repair must be replaced. With no practical way to insert a new cantilever, this can pose a real problem if the rot is extensive. Fortunately, we usually find that only one or two of the original joists are rotted to the point of being unusable. In such cases, we rely on the remaining members for structural support by installing a new, double rim joist at the outboard edge and tying it to each solid joist with an upside-down joist hanger (Figure 4).

This beefed-up rim hangs from the sound joists, providing outboard support to the few joists that must be completely replaced. The inboard ends of the replaced joists rest on the wall plate, while the outboard ends are supported by conventionally installed joist hangers at the rim — an approach that shifts the load from these replaced “cripple joists” to the repaired and sistered joists through the rim.

Figure 4. Joists that are too far gone to repair must be replaced between the wall plate and the new double rim joist (left). The rim hangs at the ends of the intact cantilevered joists on upside-down joist hangers. The replaced “cripple joists” are hung conventionally (right).

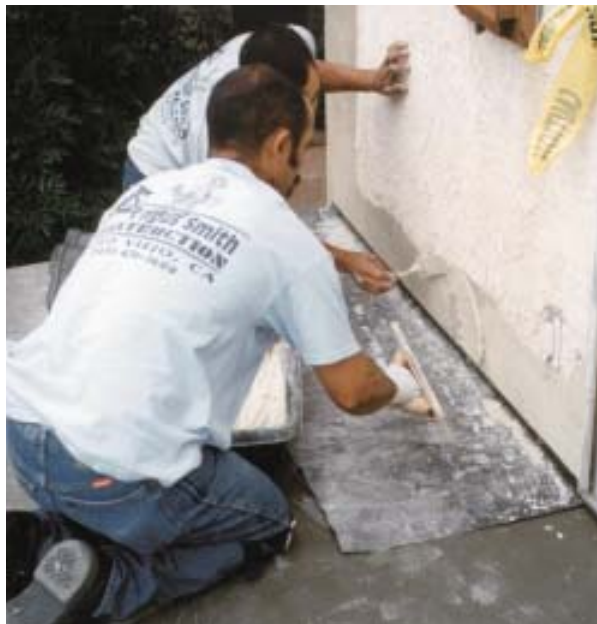
Once the texture coat can be walked on, we complete the patching of the stucco siding, following the original steps of 60-minute building paper, stucco lath (wire), scratch coat, brown coat, and a color and texture coat. Usually, we're patching small areas, so we use a quick-drying mortar mix to help expedite the job (Figure 7). We take the stucco down over the apron flashing but not all the way to the deck, leaving a narrow band of metal exposed. This allows for some necessary structural movement and elimi-

Figure 7. Stucco siding repairs follow the original three-layer process of scratch coat, brown coat, and color coat. A narrow strip of the sheet-metal flashing is left exposed to allow crack-free movement between wall and deck.

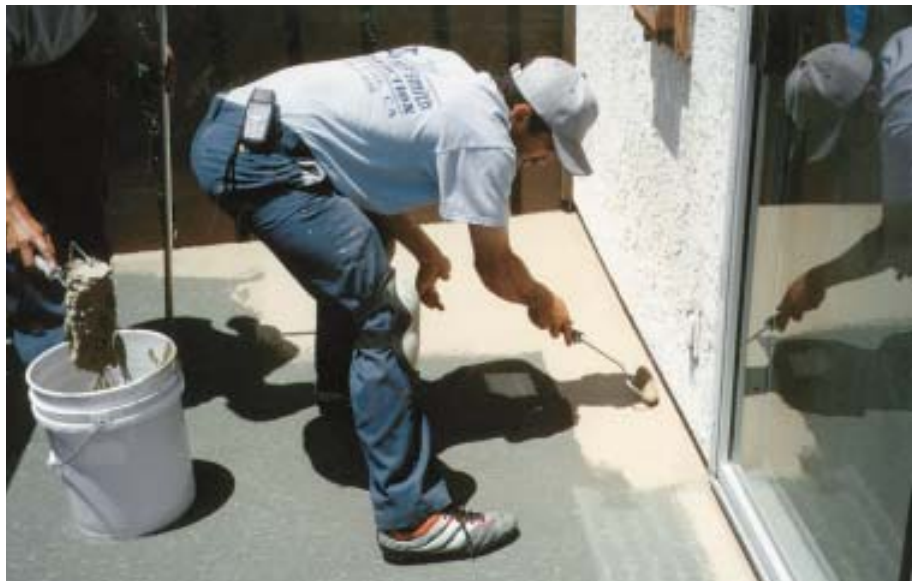
Figure 8. A final, acrylic color coat seals and protects the multilayered deck system from water absorption.

A proprietary acrylic color coat seals and completes the deck surface treatment (Figure 8). The deck can be walked on within about 4 hours, but it's best to wait 24 hours before putting the surface to regular use.
