CANTILEVERED BALCONIES – KEEP AN EYE ON THEM

By Angus Smith

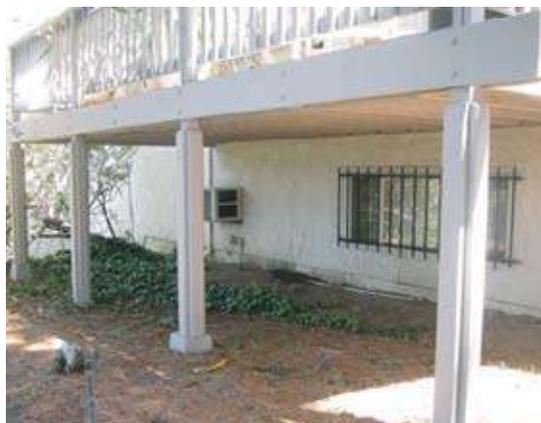
Conventional balcony design with outboard edge supported by posts and beams

Maintenance is important to the protection of all types of balconies, but it is of particular importance to cantilevered balconies. Replacement of decayed components on conventional post and beam structures are easier and less expensive than their cantilevered counterparts. Because the cantilevered wood joist is an important feature of the attached structure's interior subfloor system, correction of wood decay problems become more challenging. Should complete replacement of these joists be necessary, it would mean demolition of a substantial area of the unit's interior. This would result in considerable expense to the association and inconvenience to the resident. Balcony repair specialists have developed effective techniques that can avoid this outcome if

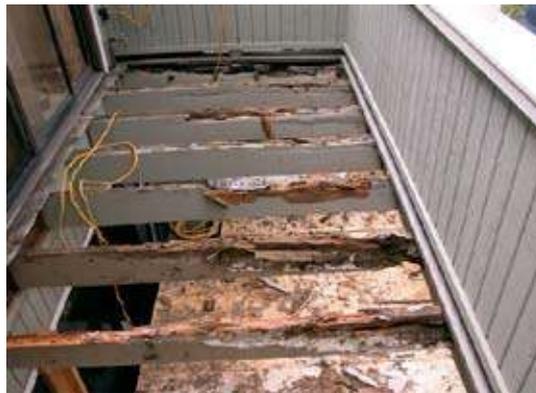
Severe decay in cantilevered floor joists

The cantilevered balcony has no support at the outboard end. The continuation of the wood joists into the structure interior is the formula that makes the system possible. This continuous penetration of a wood member into the building interior can also be

decay is not severe. However, if association maintenance is inadequate, severe decay and worst-case-scenario repairs will be likely.

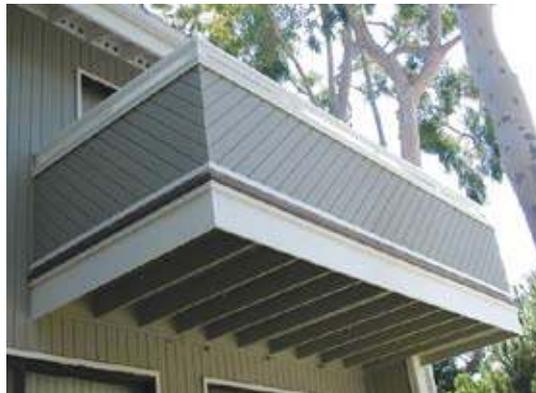
Reconstructed cantilevered balcony

Composite- and decay-resistant material should be incorporated into balcony and railing repair/replacement as much as possible.

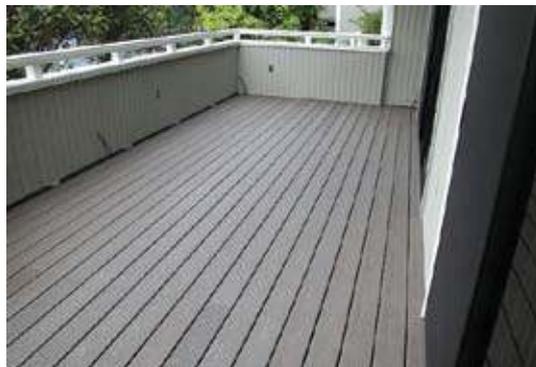
Balcony with a gapped decking finished floor

Solid waterproofing is the most typical finish on cantilevered balcony floors. In some cases, the finished floor can be gapped decking, which is not an ideal surface, as it drains water directly onto the wood support members. If gapped decking is preferred, it's important that the wood joists below have a waterproofing membrane on top to protect them from unavoidable water drainage. Failure to install appropriate waterproofing will result in trapped moisture between joists and at the joist/decking connection. These areas create an ideal environment for the growth of fungal decay.

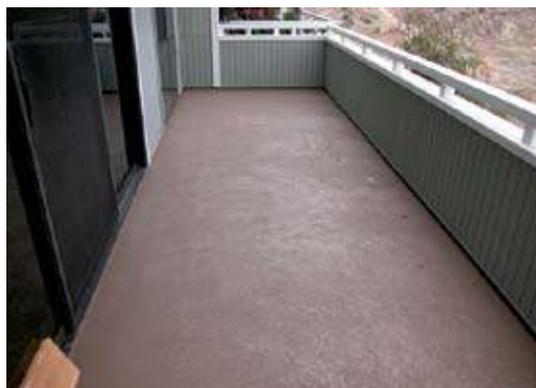
Balcony with a solid waterproofed finished floor

» **Floor surface:** Check for cracks, fractures, delamination, etc. Flaws should be corrected as soon as possible. These defects will allow water to penetrate wood subfloor, which will lead to an ongoing cycle of wet wood expanding, waterproofing fractures expanding and ultimately balcony decay and failure.
