THE JOURNAL OF LIGHT CONSTRUCTION

REPAIRING Cantilevered Balconies

by Angus Smith

The right flashing details, reinforced framing, and durable waterproof decking give new life to old balconies

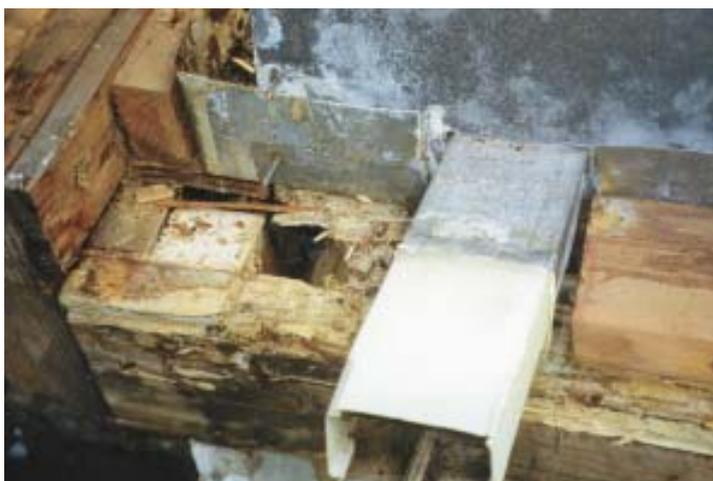
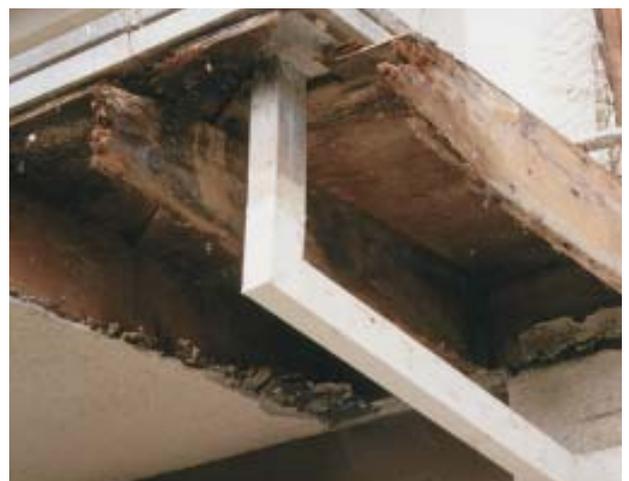
which makes for easy construction and provides privacy for the residents. It also prevents runoff from a balcony from dripping directly onto one below, but at a cost: The rainwater that falls onto each balcony must be collected and directed outside. This is usually handled by a floor drain or an open, floor-level scupper draining to a gutter. Either drainage method can lead to rot unless the spout that passes through the framing is properly installed and sealed (Figure 2).

Figure 2. Improperly flashed scuppers (left) and floor drains (right) often allow water into the framing, leading to hidden rot.

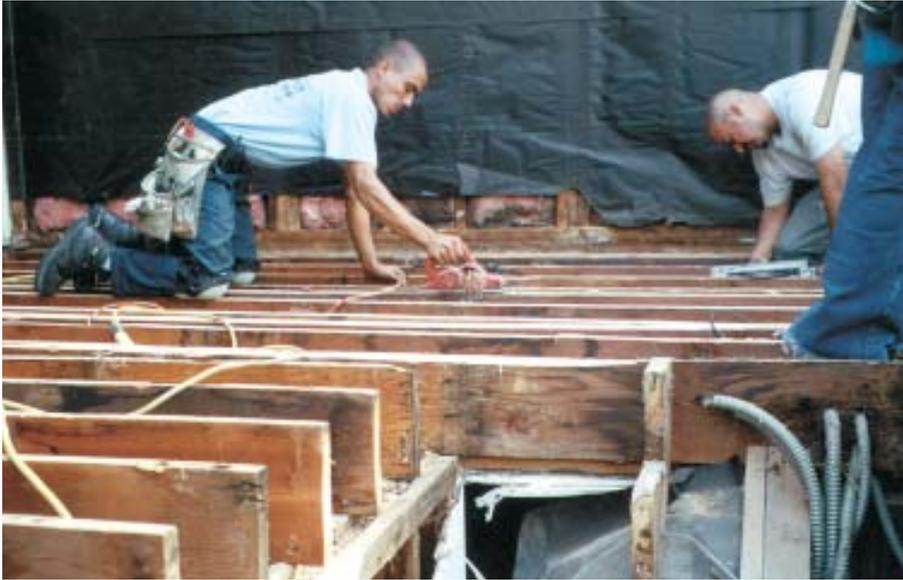
Figure 3. To eliminate puddling, the author rips a 1/4-inch-per-foot taper from the top edge of the cantilevered joists, creating a positive drainage slope. A power planer cleans up the cut.

Any top-edge rot gets ripped away to undamaged wood and replaced with a new ripping, which we simply gun-nail into place. We treat all cuts with a termite and rot repellent, Jasco Termin-8 (Jasco; 888/345-2726, www.jasco-help.com), a green, oil-based copper-naphthenate solution that helps prevent future infestation. If the original joists didn't incorporate a drainage slope, we'll rip a full-length, 1/4-inch-per-foot taper on the top edge, cleaning up the cuts afterward with a power plane (Figure 3).

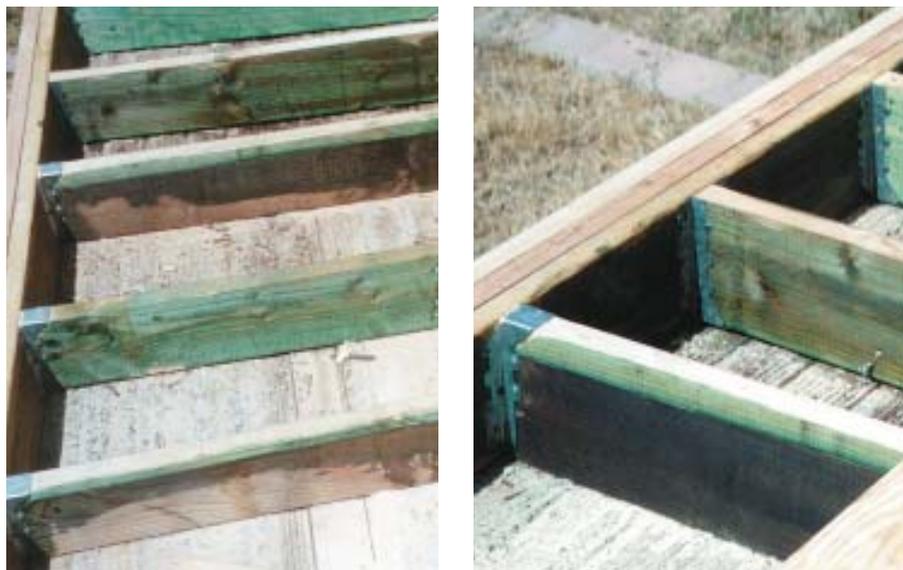
Figure 4. Joists that are too far gone to repair must be replaced between the wall plate and the new double rim joist (left). The rim hangs at the ends of the intact cantilevered joists on upside-down joist hangers. The replaced “cripple joists” are hung conventionally (right).

Shifting the load. Joists that are too far gone to repair must be replaced. With no practical way to insert a new cantilever, this can pose a real problem if the rot is extensive. Fortunately, we usually find that only one or two of the original joists are rotted to the point of being unusable. In such cases, we rely on the remaining members for structural support by installing a new, double rim joist at the outboard edge and tying it to each solid joist with an upside-down joist hanger (Figure 4).

This beefed-up rim hangs from the sound joists, providing outboard support to the few joists that must be completely replaced. The inboard ends of the replaced joists rest on the wall plate, while the outboard ends are supported by conventionally installed joist hangers at the rim — an approach that shifts the load from these replaced “cripple joists” to the repaired and sistered joists through the rim.

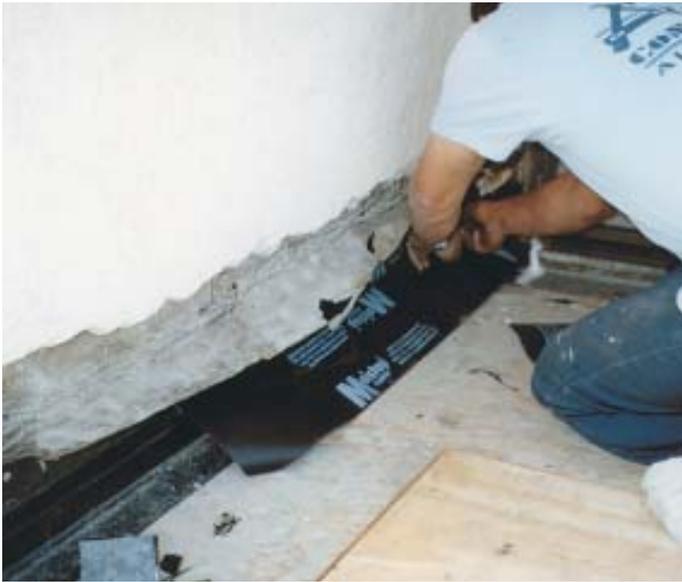
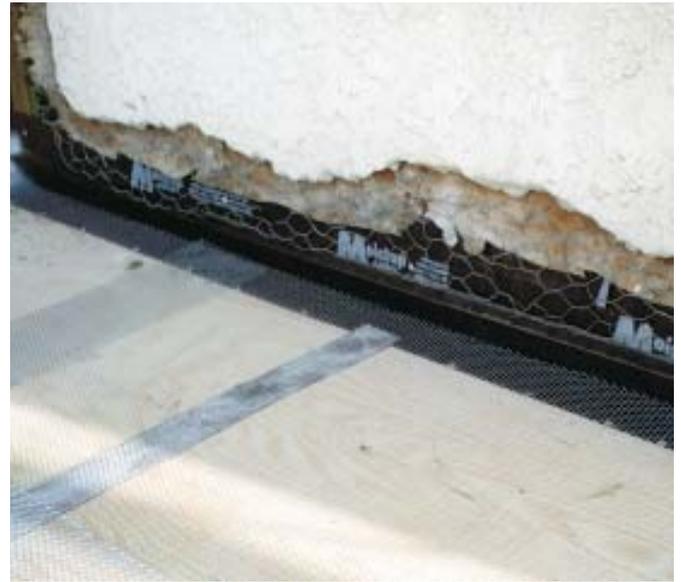
Figure 5. Flexible membrane flashing, tucked behind existing building paper and overlapping a sheet-metal skirt flashing, provides positive wall drainage onto the new balcony surface.

except where a shear panel is required. Instead, stucco lath is applied directly to the studs over 60-minute building paper. To make sure that the transition from deck to sidewall is watertight, we break the stucco (or other siding) back about 6 inches up the wall and run a 9-inch-wide Moistop strip over the sidewall framing, behind the original building paper and over the flange of the 26-gauge bonderized, galvanized sheet-metal (C&J Metal Products,

Long Beach, Calif.; 800/500-8660, www.cjmetals.com) transition flashing that runs onto the deck surface (Figure 5, previous page).

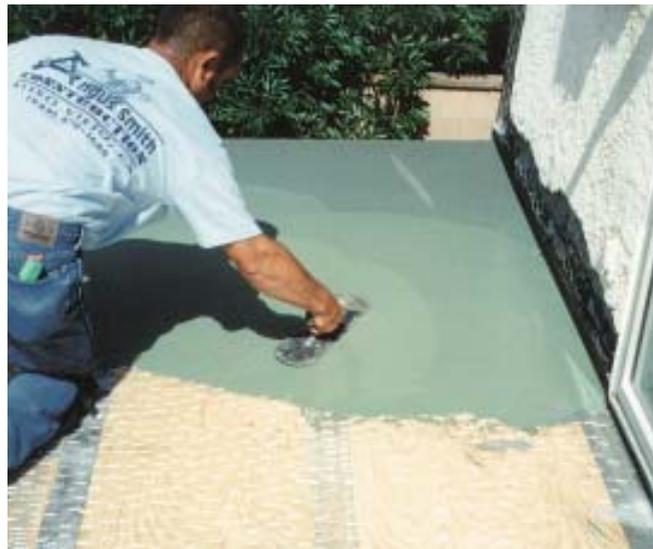
Figure 6. Galvanized expanded metal lath, thoroughly stapled to the plywood deck, reinforces the cementitious waterproofing membrane. Plywood expansion joints are isolated and protected from filling by a proprietary seam tape.

First, we install bonderized sheet-metal wall flashing and drip edge, nailing it directly to the plywood and sealing overlaps with an approved polyurethane caulk. To prevent the expansion joints between plywood sheets from filling up, we cover them with self-adhesive, 40-mil-thick Life Deck Seam Tape. Then we install a layer of galvanized expanded metal lath over the plywood and flashing and thoroughly fasten it with a pneumatic stapler, using at least 16 staples per square foot (Figure 6, previous page). The base coat — a thick, soupy mix of cement and acrylic polymer — is poured on and troweled into the lath. After the base coat cures, we trowel on a similar, slurry layer to build up the membrane and fill any voids. The third, texture-coat layer is splattered on using a hopper-fed texture gun, at about a 70% coverage rate, and knocked down with a steel trowel while wet.

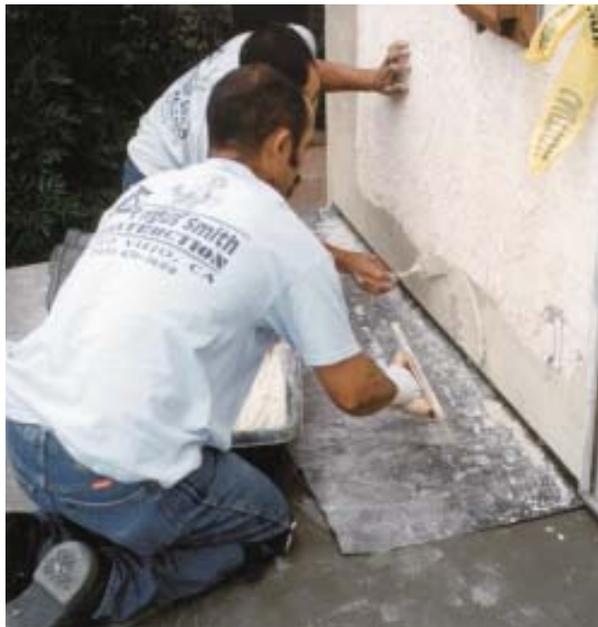
Figure 7. Stucco siding repairs follow the original three-layer process of scratch coat, brown coat, and color coat. A narrow strip of the sheet-metal flashing is left exposed to allow crack-free movement between wall and deck.

Once the texture coat can be walked on, we complete the patching of the stucco siding, following the original steps of 60-minute building paper, stucco lath (wire), scratch coat, brown coat, and a color and texture coat. Usually, we're patching small areas, so we use a quick-drying mortar mix to help expedite the job (Figure 7). We take the stucco down over the apron flashing but not all the way to the deck, leaving a narrow band of metal exposed. This allows for some necessary structural movement and elimi-

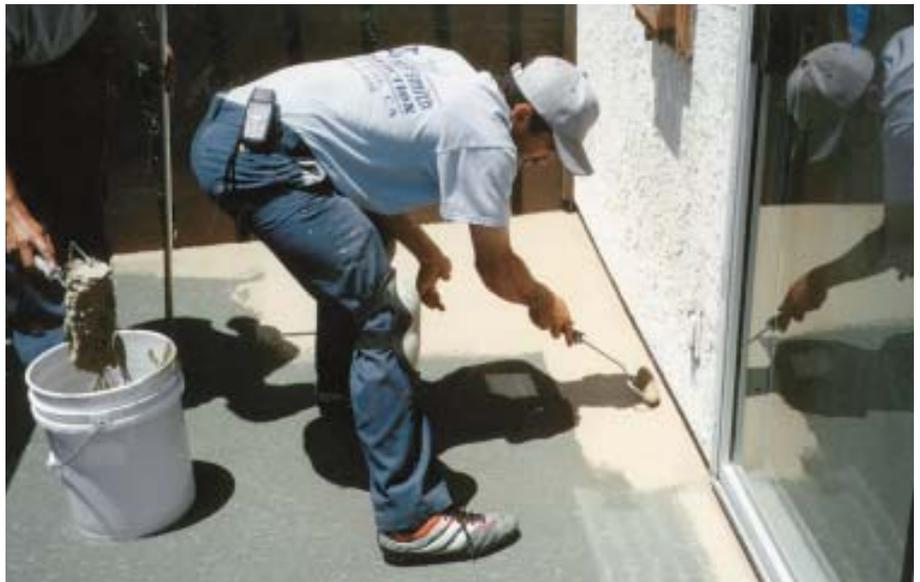
Figure 8. A final, acrylic color coat seals and protects the multilayered deck system from water absorption.

A proprietary acrylic color coat seals and completes the deck surface treatment (Figure 8). The deck can be walked on within about 4 hours, but it's best to wait 24 hours before putting the surface to regular use.
